# Lucas Heights Bioenergy Facility

**Preliminary Site Investigation (PSI) for  
Contamination**

LMS Energy Pty Ltd

October 2025

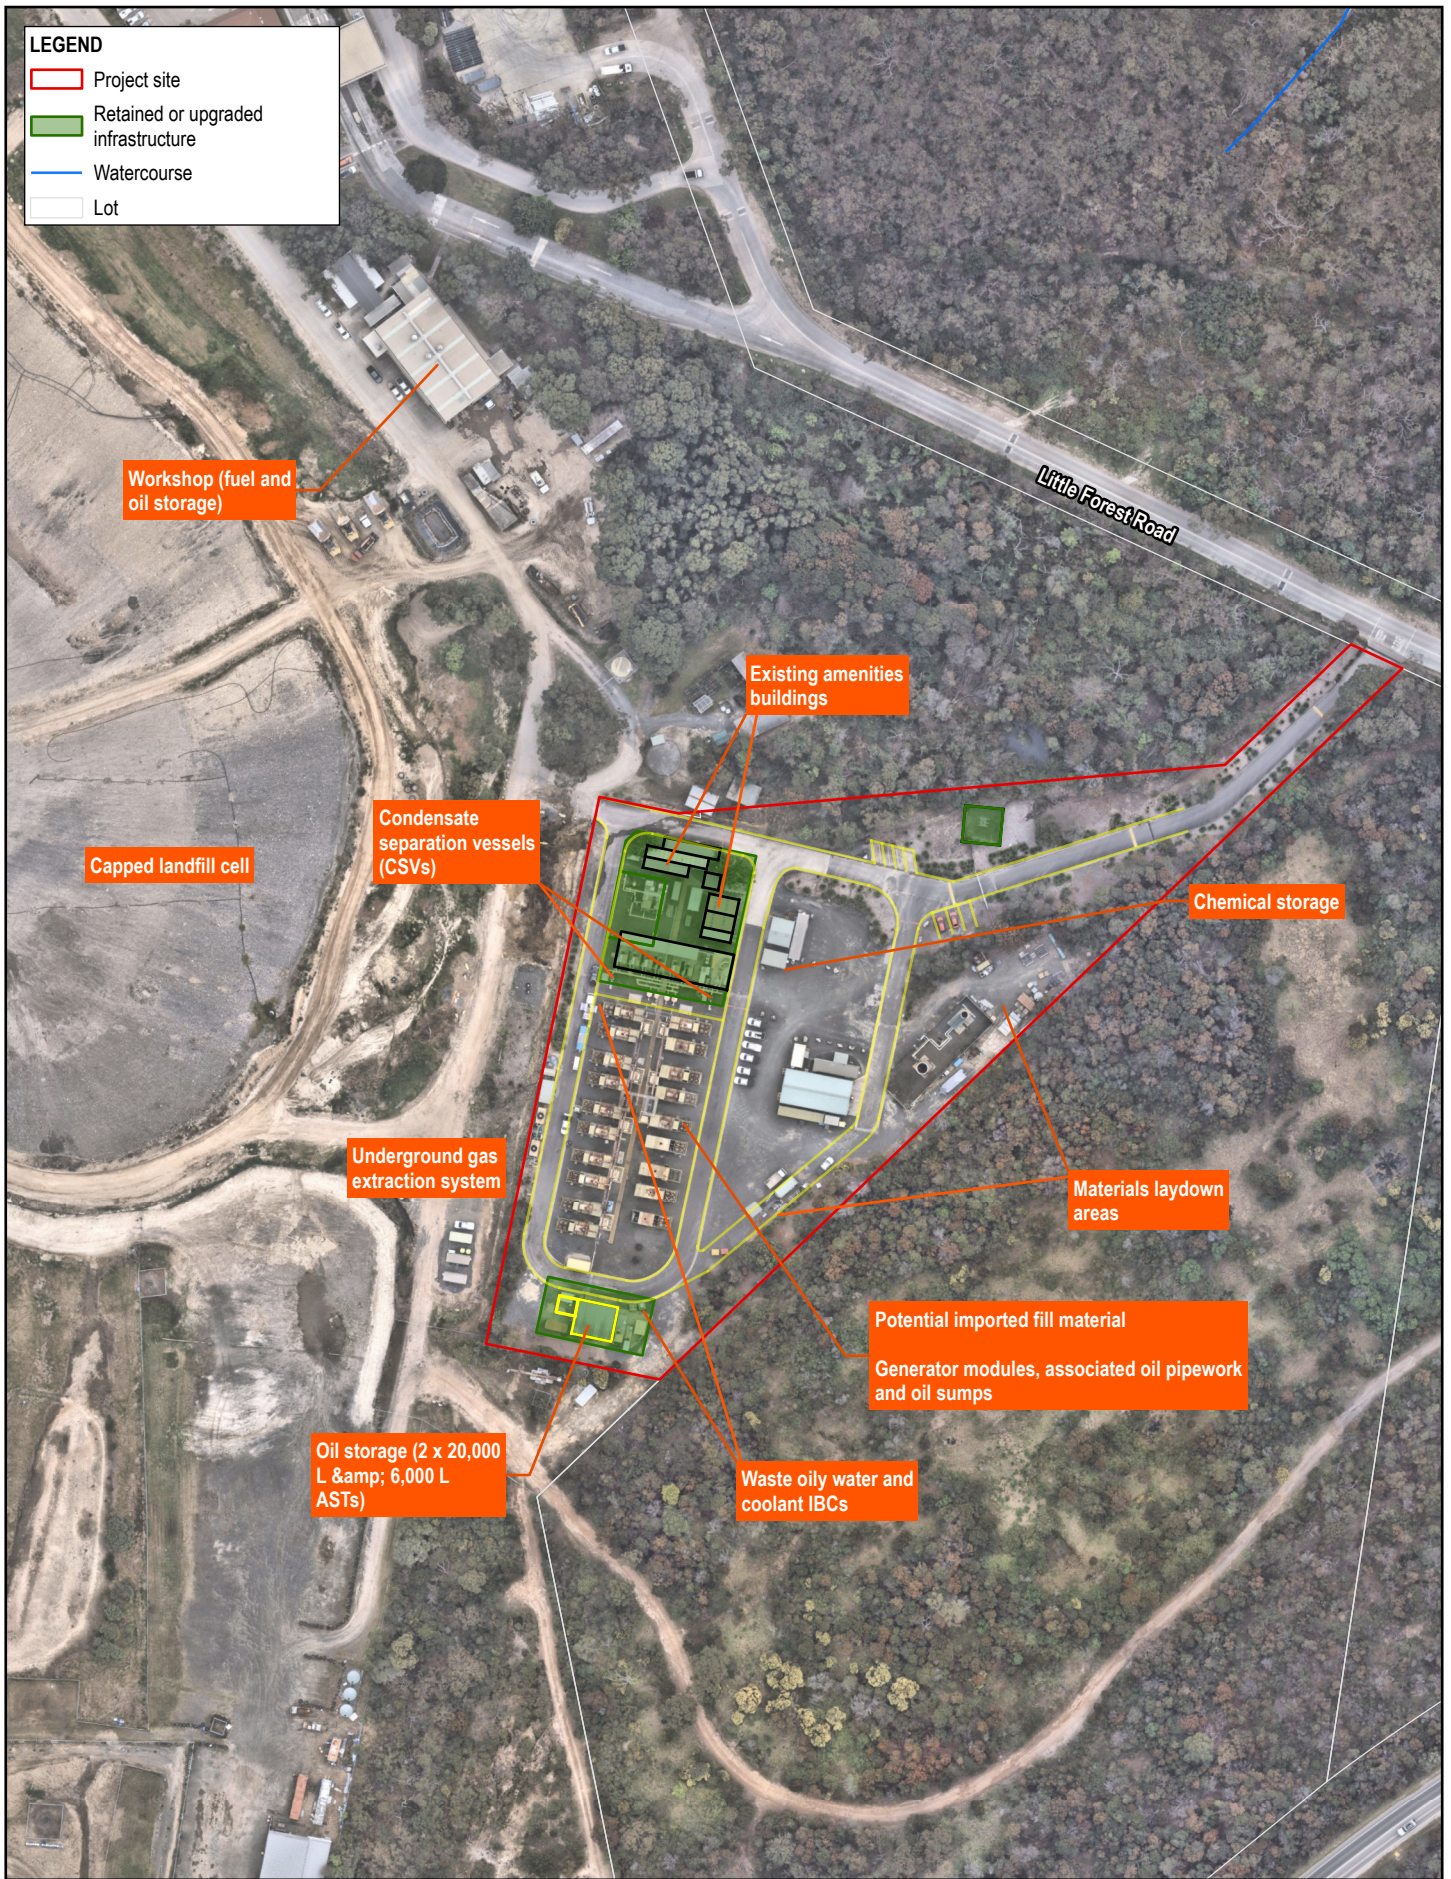
**FIGURE 2.1**

**Existing site layout**

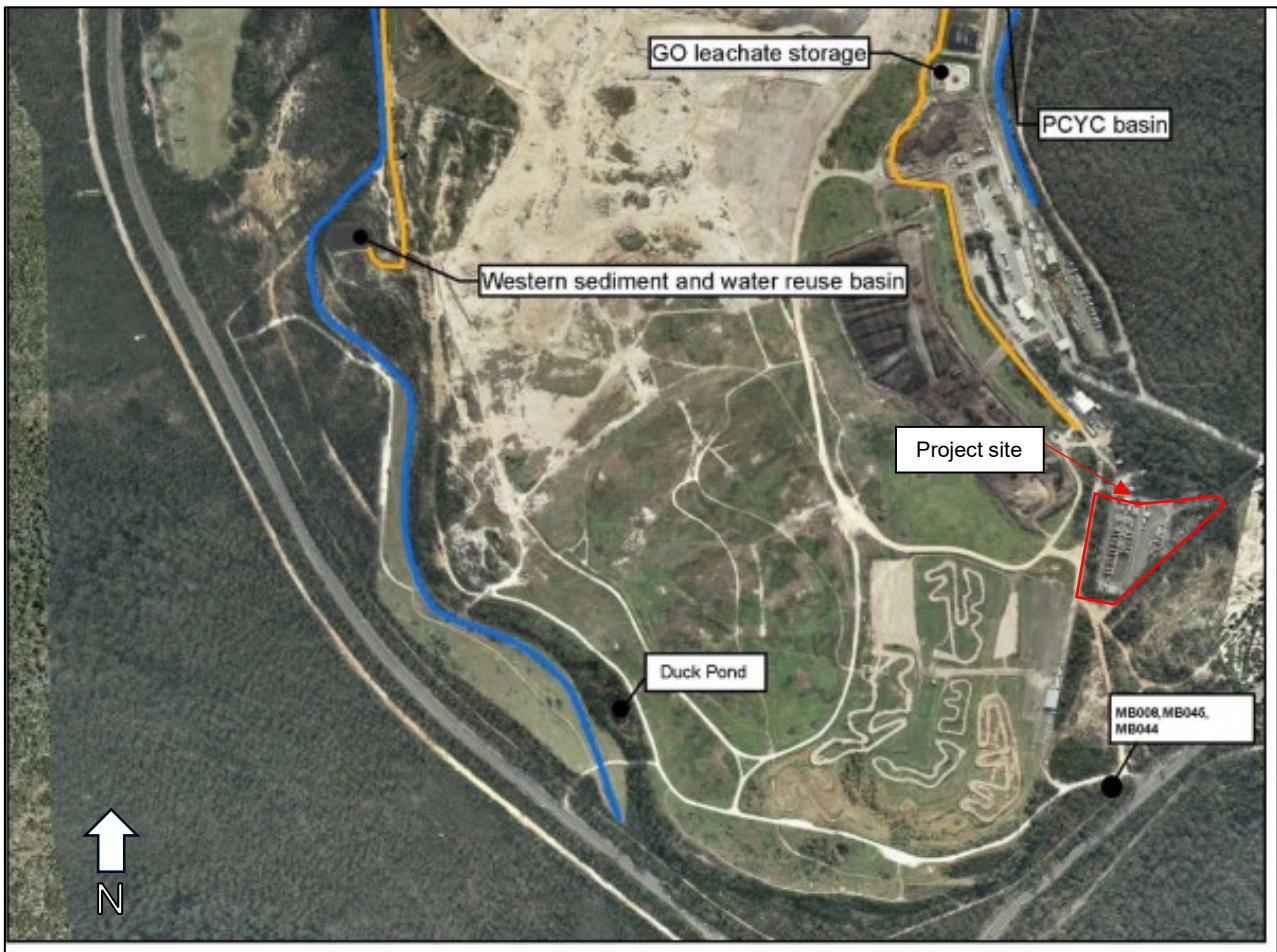
Figure 3.1 Groundwater well locations close to the project site (extracted from OEMP (Cleanaway, 2025))

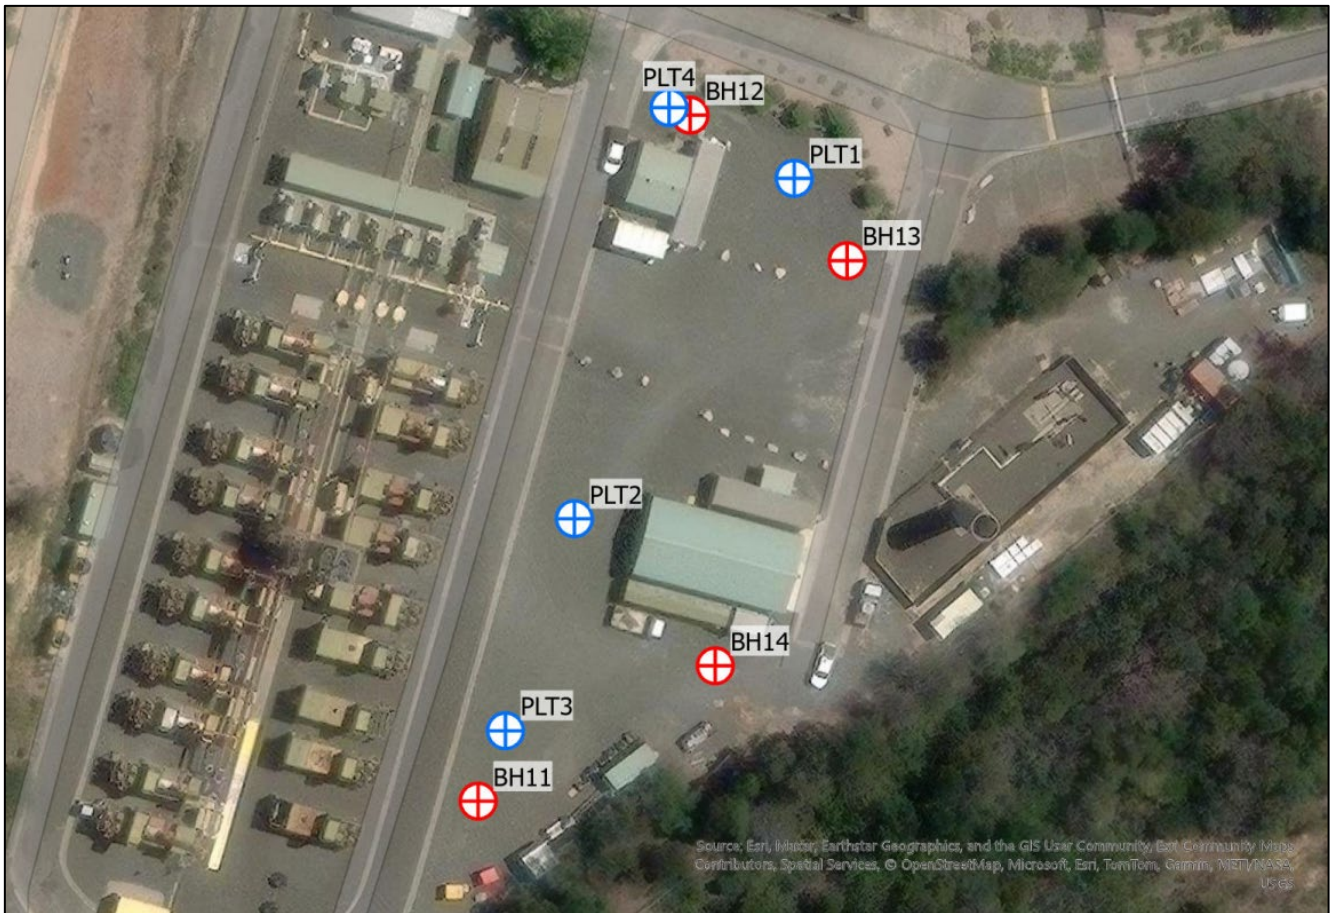
Figure 4.4 Location of geotechnical investigation boreholes (GHD, 2025)

- No potential asbestos containing material (ACM) was observed during the site walkover.
- Groundwater wells were not observed on the site at the time of the inspection, however, BH14 was observed from markings on the surface (refer to Figure 4.4).

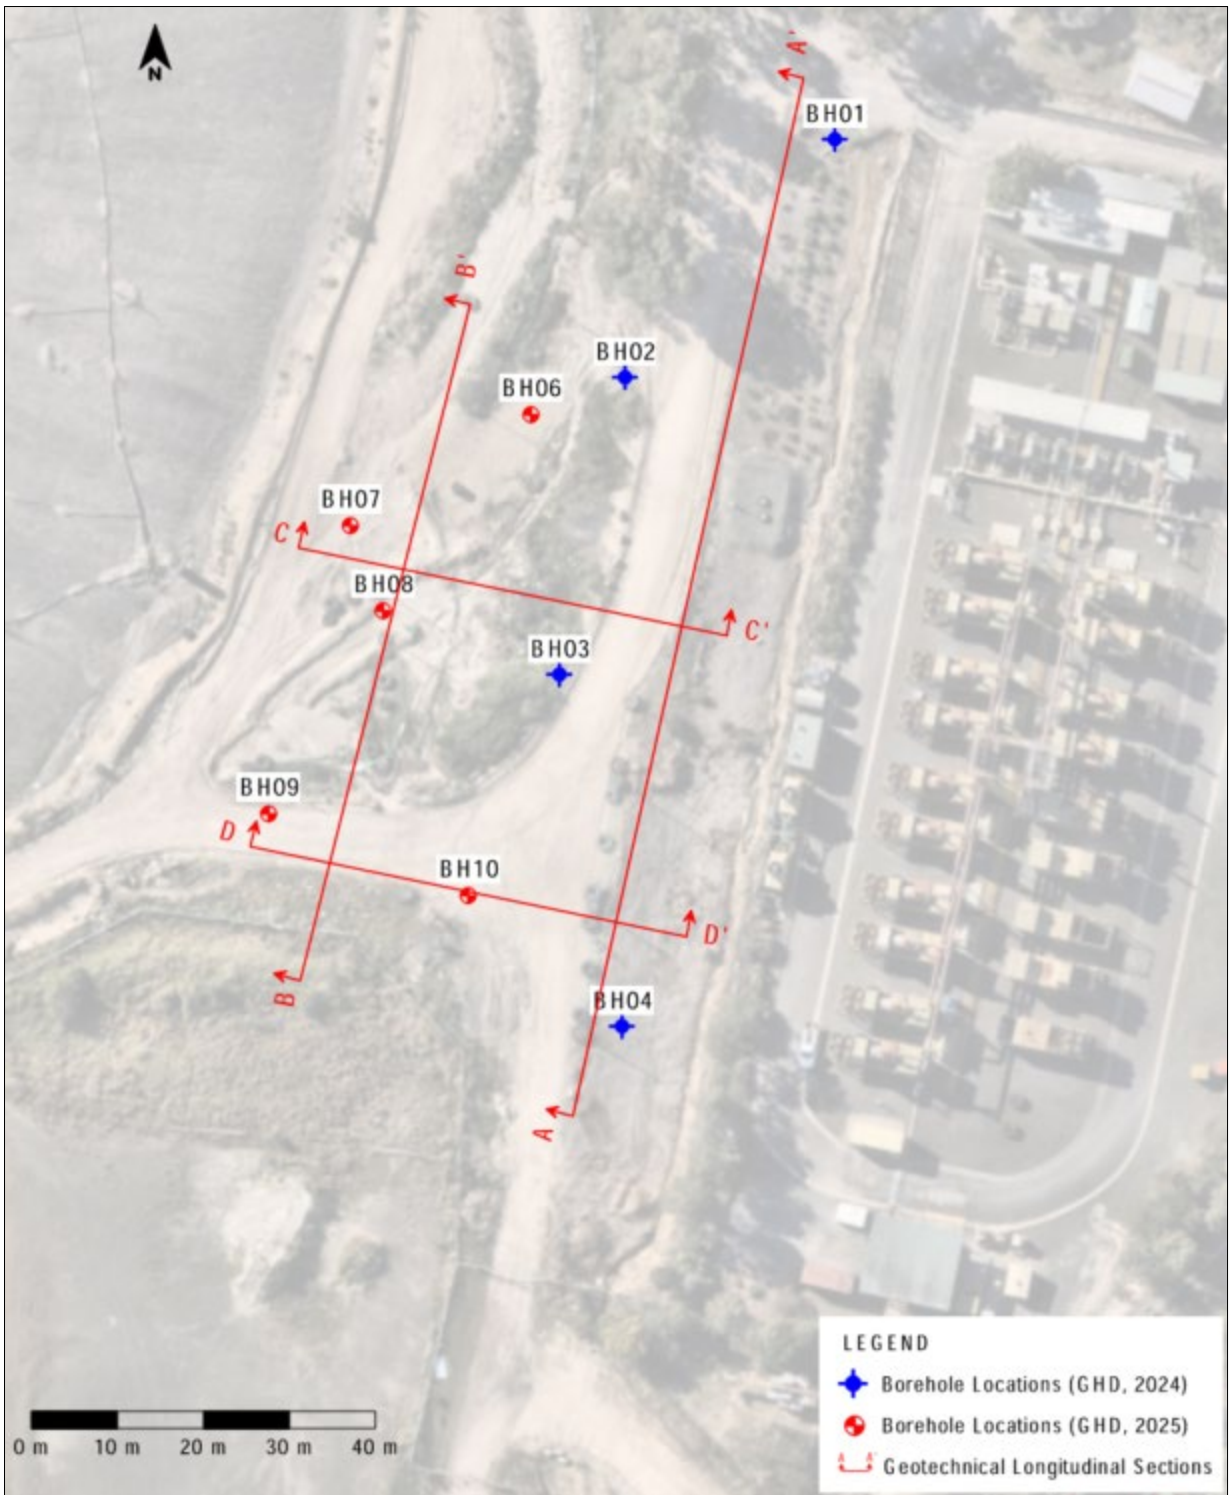
Figure 4.5 Locations of geotechnical investigation boreholes (GHD, 2024)

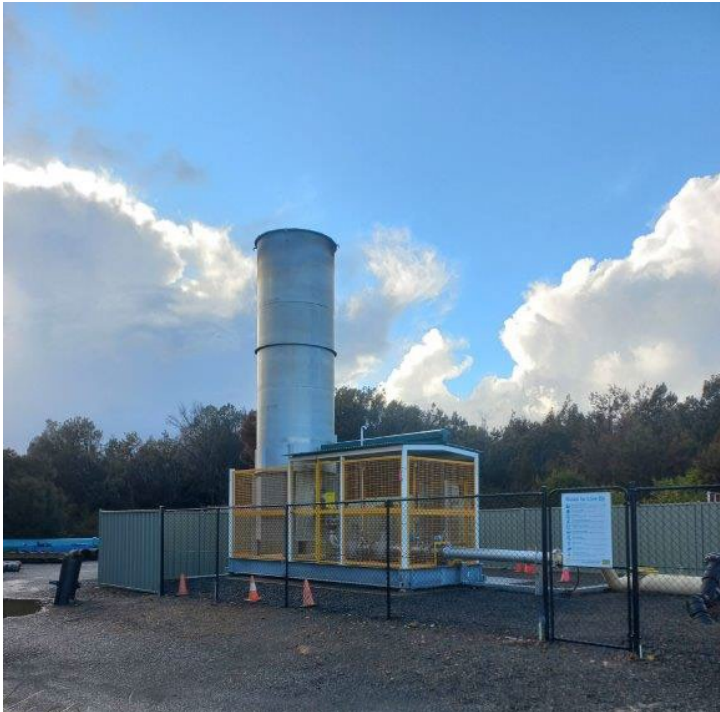
<p><b>Plate no. 1</b></p>

<p><b>Description:</b> View east towards flare compound on eastern boundary.</p>

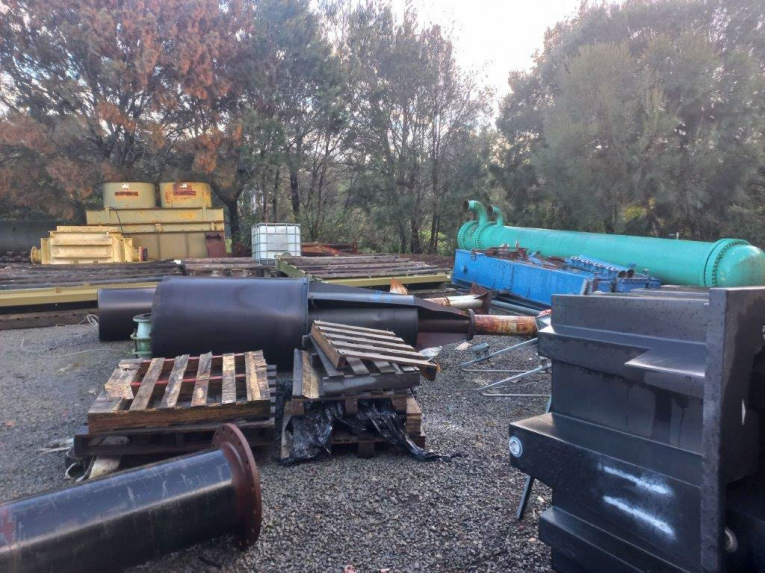
<p><b>Plate no. 5</b></p>

<p>A photograph showing a waste storage area. In the foreground, there are several large, dark-colored pipes and a wooden pallet. In the background, there are more pipes, a blue pipe, and a yellow container. The area is surrounded by trees with autumn foliage.</p>
<p><b>Description:</b> View to north west in the waste storage area.</p>	
<p><b>Plate no. 6</b></p>

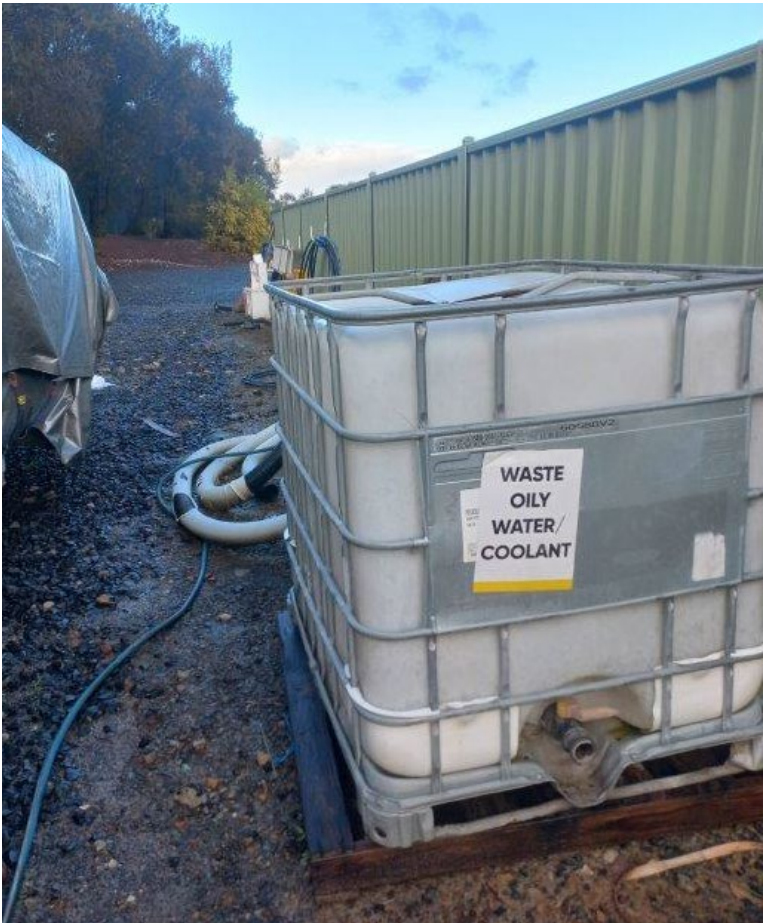
<p>A photograph showing a waste storage area. In the foreground, there is a large, white, rectangular IBC container with a metal frame. The container has a label that reads "WASTE OILY WATER/ COOLANT". To the left of the container, there is a boat covered with a grey tarp. In the background, there is a green metal building and a gravel area.</p>
<p><b>Description:</b> View south west from the flare compound close to site boundary, empty IBC, plastic flexi tubing and boat visible (left hand side of image).</p>

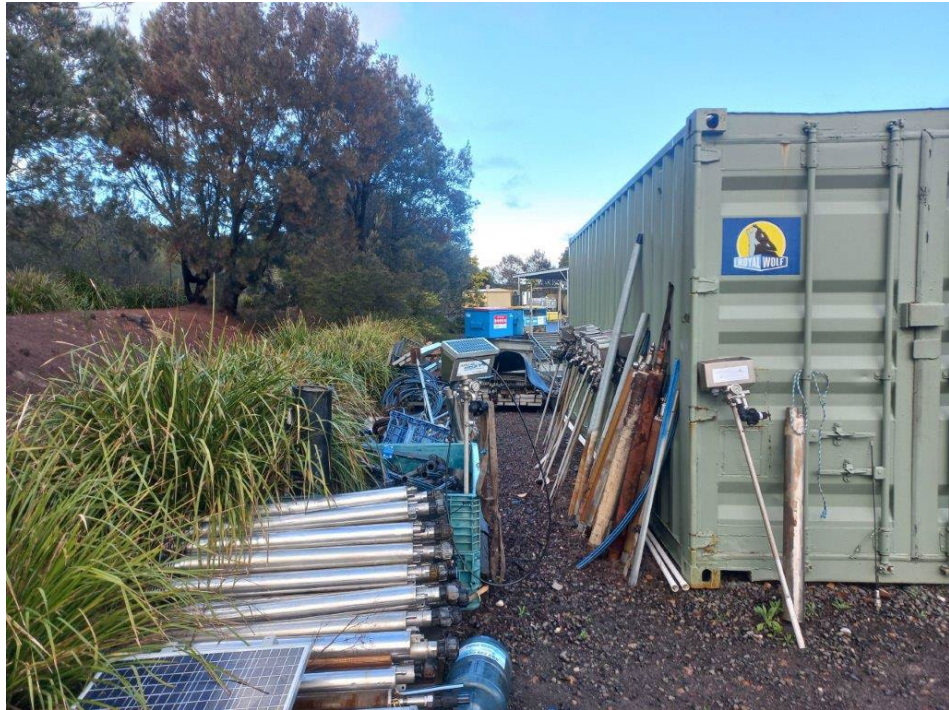
**Plate no. 7**

**Description:**  
Shipping container and waste items along eastern boundary of the site, 30 m to the north of flare compound.

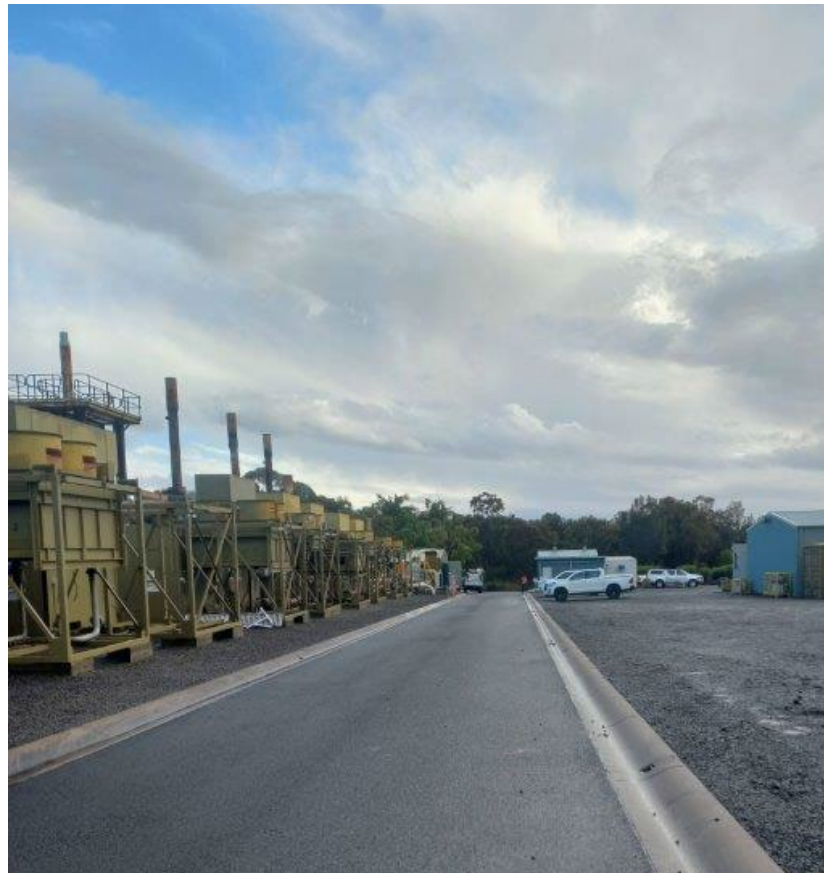
**Plate no. 8**

**Description:**  
General view north along access road in central portion of the site (generator modules on left hand side of image).

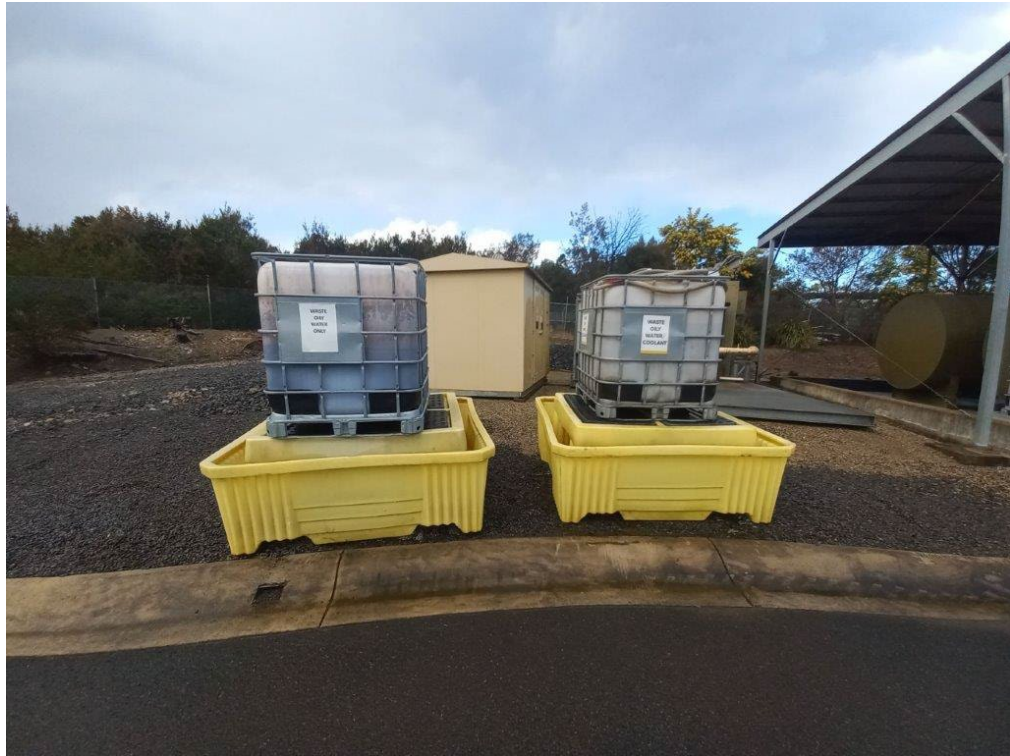
Plate no. 9

Two waste oily water / coolant IBCs set on portable bunds in southern area of the site adjacent to the ASTs. Rainwater observed in bund, no obvious signs of sheen or oil residues.

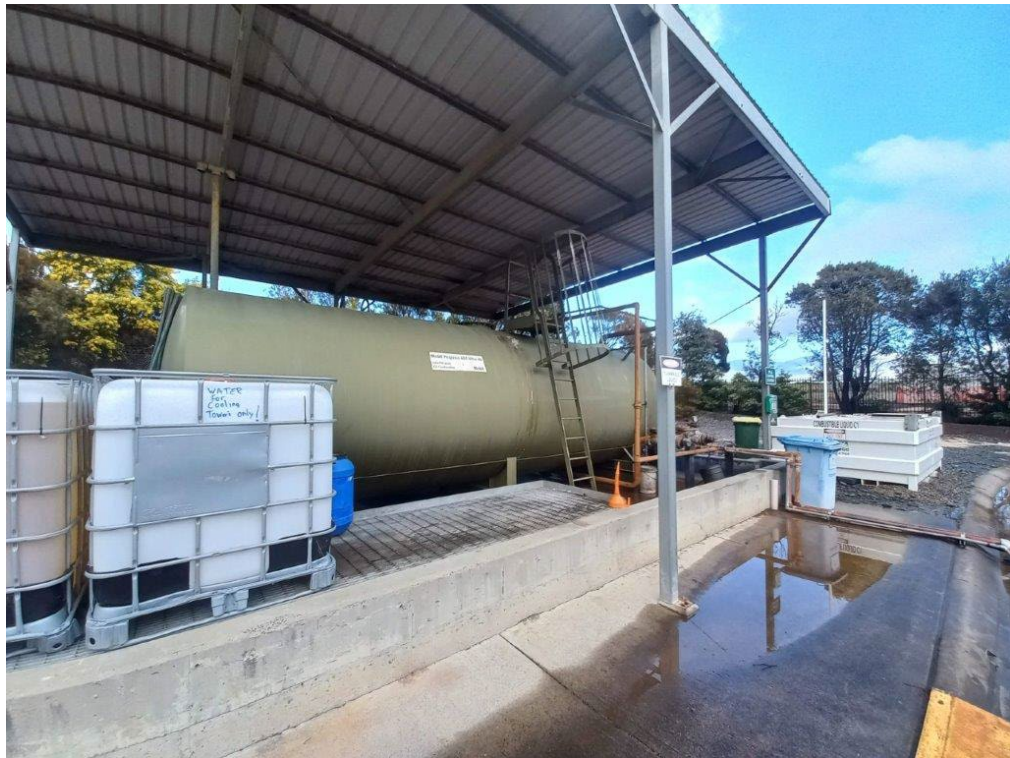
Plate no. 10

Location of 2 x 20 KL oil ASTs with concrete bund. 6,000 L AST in background. No evidence of leaks from pipework outside the bund. No evidence of leaks inside bund i.e., no sheen on rainwater, no product visible.

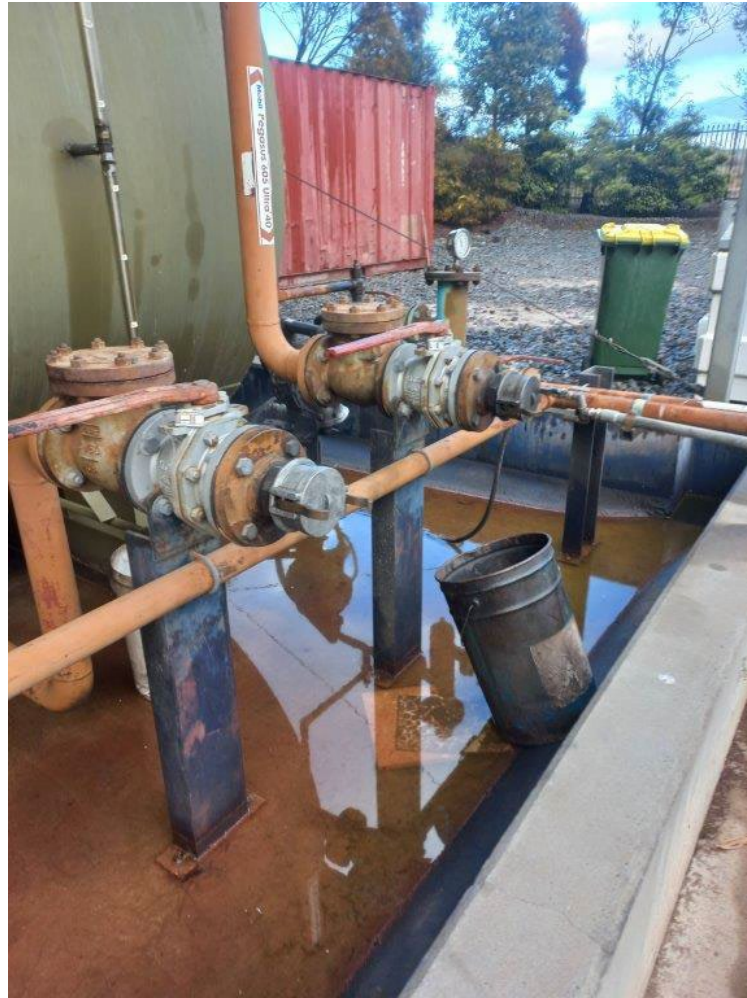
**Plate no. 11**

**Description:**  
Two fill points for the 20 KL ASTs set inside the bund.

- The fill points for the tanks were observed to sit in the bund and there was no staining or product observed on rainwater that was pooling in the bund. There were also two IBCs set within the bund.

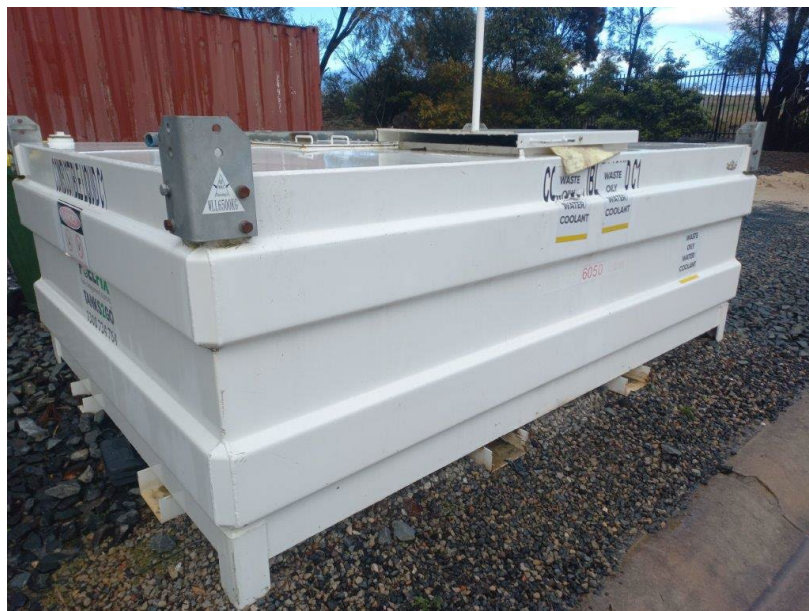
**Plate no. 12**

**Description:**  
6,000 L AST for oil storage – self banded steel tank

- A white, self-bunded, 6,000 L rectangular AST was observed adjacent to the two 20,000 L ASTs. This tank had been labelled with 'waste oily water coolant'. It was noted that the labels had been placed over signage that stated 'Combustible C1'. The tank was used for draining engine oil filters from the generators. Staining was not observed on the ground surface surrounding this AST.

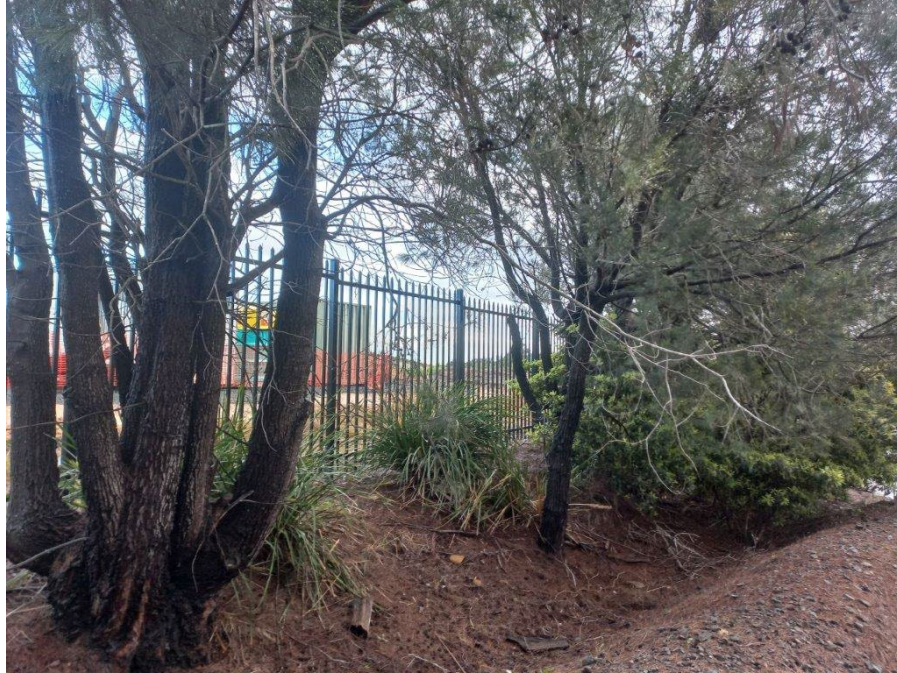
**Plate no. 13**

**Description:**  
View west of western boundary with soil embankment and vegetation along boundary

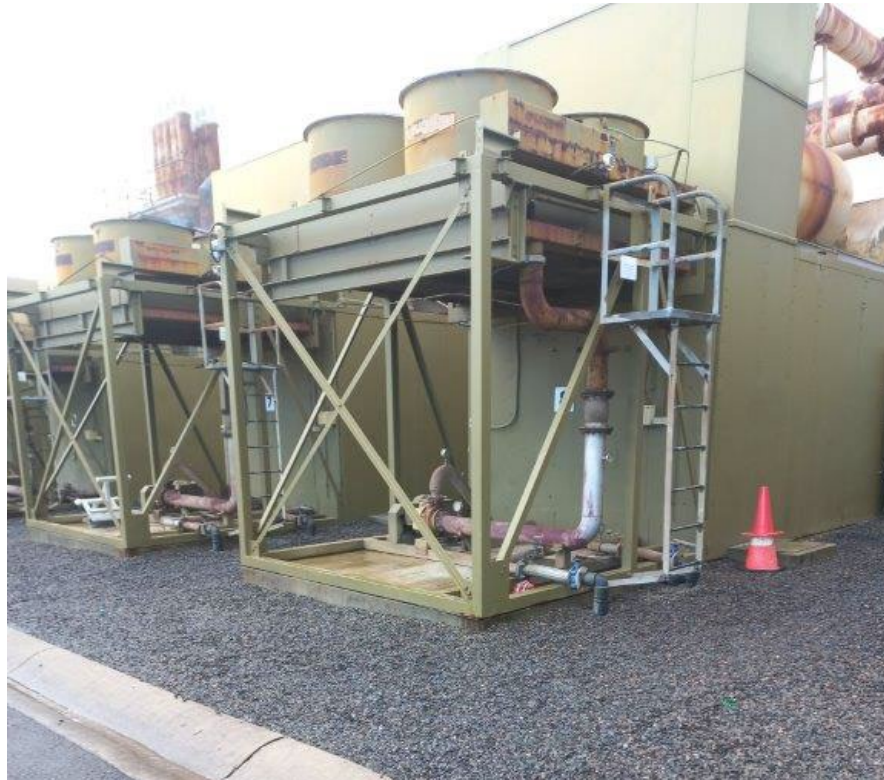
**Plate no. 14**

**Description:**  
Typical generator module set up with concrete base

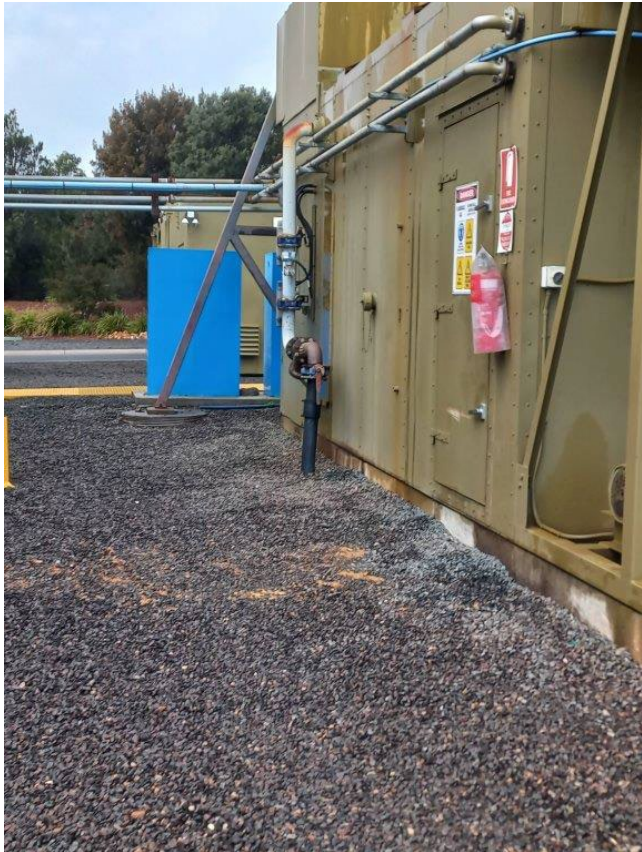
<p><b>Plate no. 15</b></p> <p><b>Description:</b> Typical view between generator modules with concrete base and gravel surround, also note above and below ground pipework</p>

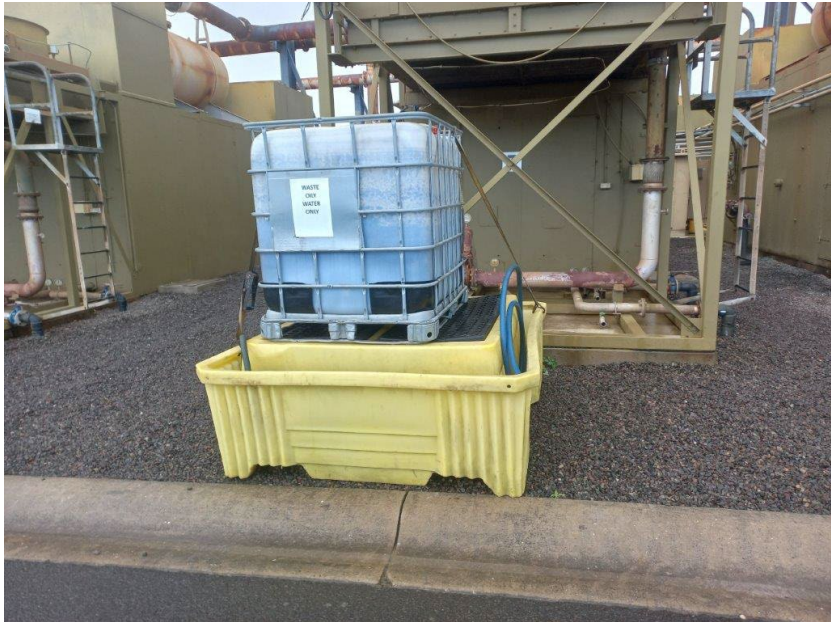
A photograph showing a waste oily water Intermediate Bulk Container (IBC) set on a portable bund. The IBC is a large, blue, rectangular container with a metal frame. It is placed on a yellow, plastic, portable bund. The bund is situated on a gravel surface adjacent to the generator modules. The background shows the tan-colored metal cabinets and various pipes and conduits.

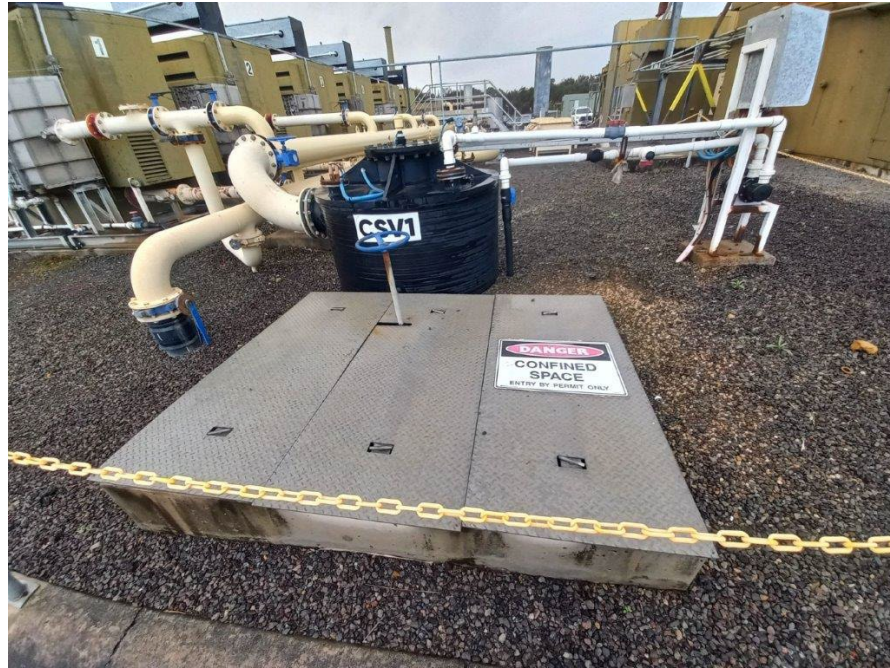
**Plate no. 17**

**Description:**  
Condensate storage vessel adjacent to generator modules in north western area of the site.

- Two condensate separation vessels (CSVs) were observed on site at the time of the site inspection. These are used to separate condensate produced as a result of condensation from the landfill gas. The CSVs were reported to pump collected condensate (leachate) back to the landfill leachate treatment system via an underground pipe. The CSVs were partially buried and leaks were not observed from the portion that was visible at ground surface.

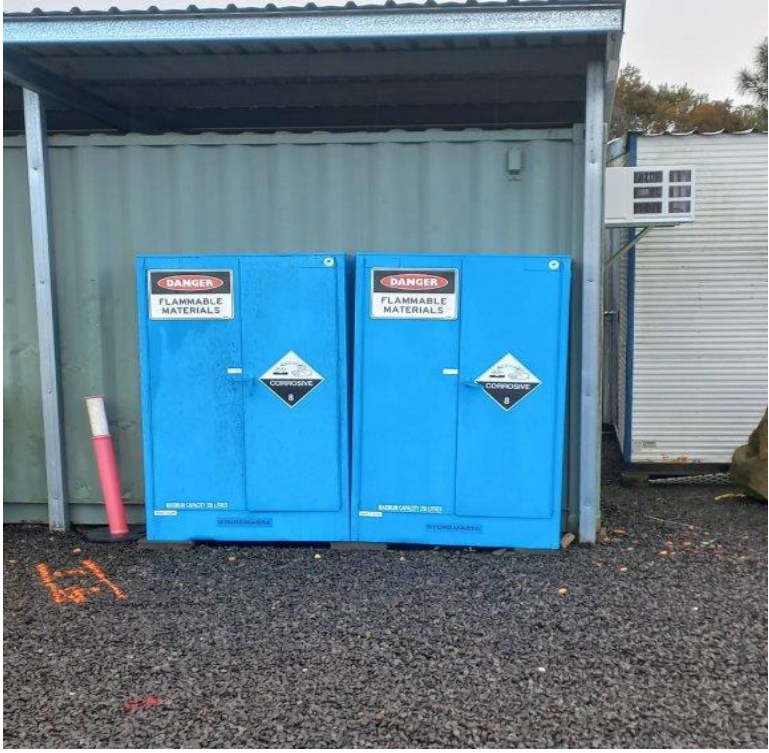
<p><b>Plate no. 21</b></p>

<p>The photograph shows two blue metal chemical storage units positioned side-by-side under a sheltered area. Each unit has a red 'DANGER' label at the top that reads 'FLAMMABLE MATERIALS'. Below this, a diamond-shaped hazard label indicates 'CORROSIVE'. The units are situated on a gravel surface, and a red fire extinguisher is visible to the left of the units.</p>
<p><b>Description:</b> 2 x chemical storage units located close to main offices in north western area of the site.</p>	<p><b>Plate no. 22</b></p>

- Two self-contained hazardous chemical storage units (containing a series of 5 to 20L drums of hydraulic oils, paint remover, lubricants, diesel fuel treatment oil and degreasers) were observed. Minor staining was observed on the floors of each of the shelves and base of the storage unit. Staining was not observed on the ground surface surrounding these units.

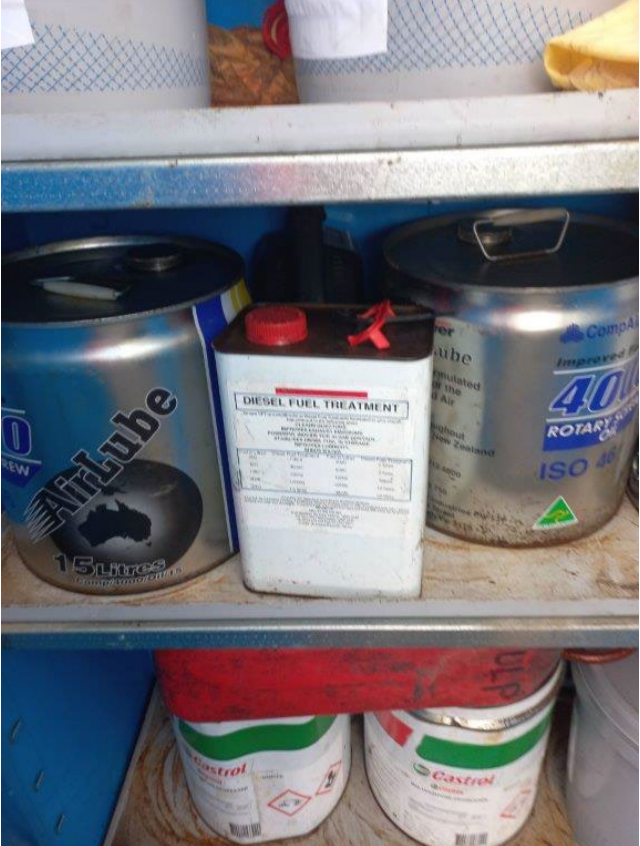
<p>The photograph shows the interior of a chemical storage unit. On a metal shelf, there are three containers: a 15-litre can of AirLube oil, a white plastic jug of Diesel Fuel Treatment, and a 40-litre can of Castrol 4000 ISO 46 oil. Below the shelf, two more Castrol oil cans are visible.</p> <p><b>Description:</b> Typical contents of the chemical storage units.</p>
